QUAKAKE DAM

NDI ID NO. PA-00613
DER ID NO. 13-11

HAZLETON CITY WATER AUTHORITY

PHASE I INSPECTION REPORT
NATIONAL DAM INSPECTION PROGRAM

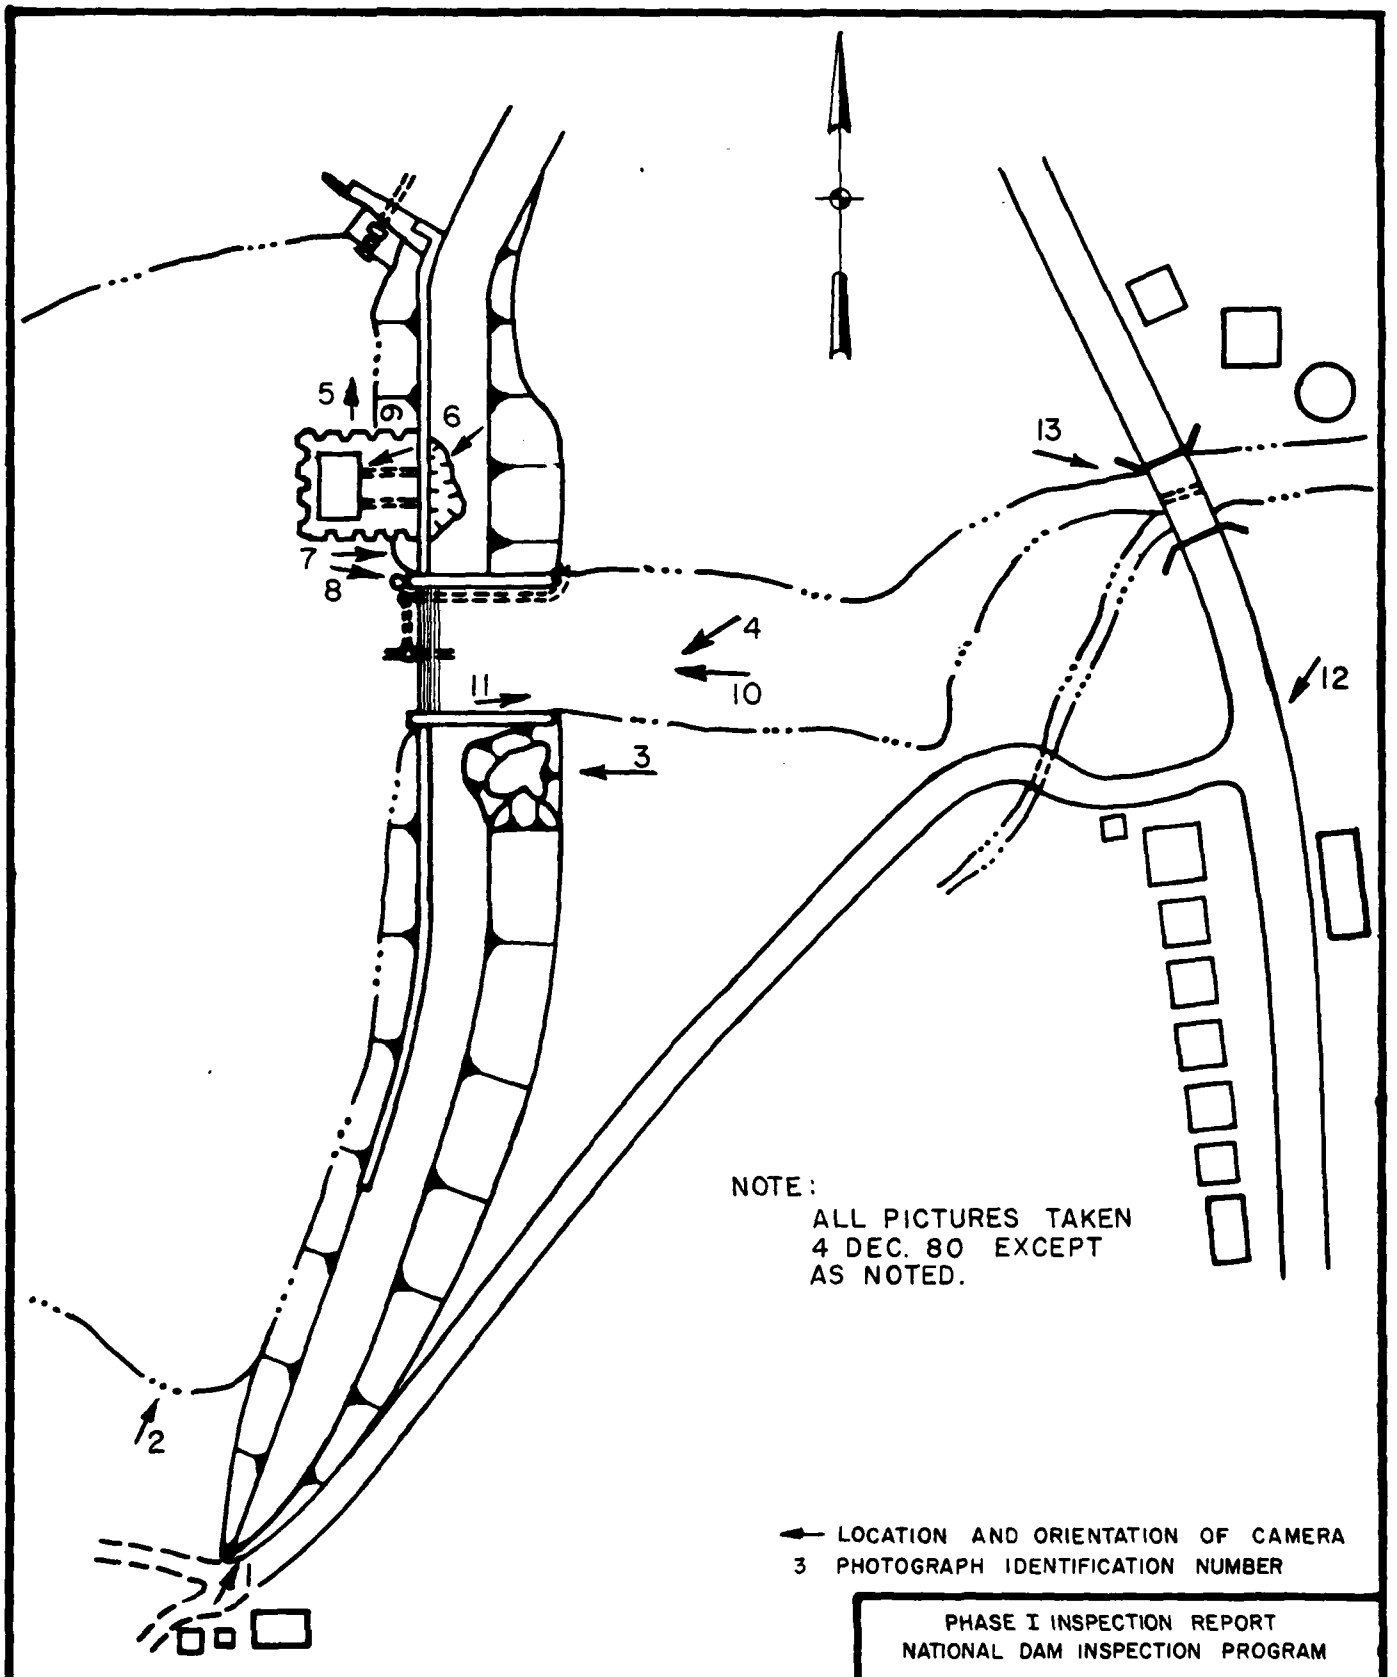
4. Right spillway wall and eroded downstream face.

5. Upstream face and left abutment. Existing water supply intake structure.

5. The deteriorated concrete of the spillway walls should be repaired.

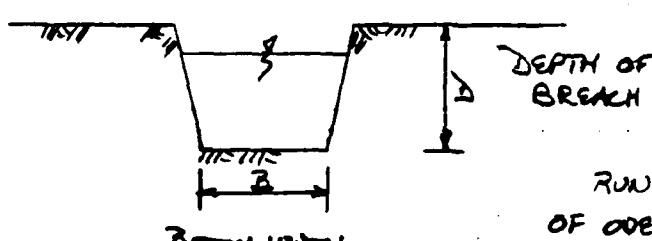
TYPICAL BREACH SECTION

THIS FACILITY CAN HANDLE 9% OF THE PMF. AT THE SDF (½ PMF), THE DAM IS OVERTOPPED TO A MAXIMUM HEIGHT OF 3.60 FEET FOR A TOTAL DURATION OF ~8.3 HOURS. SINCE IT IS FELT THAT AT 50% OF THE PMF THE DAM WOULD FAIL DUE TO OVERTOPPING, A BREACH ANALYSIS IS REQUIRED.

RUN BREACH AT ~0.5 FEET OF OVERTOPPING. THEREFORE, RUN 13% PMF TO BREACH.
